Guardian Residential Services, Inc.

# Inspection Report

**Property Address:**  
186 South Drive  
St. Simons Island Ga 31522

<b>Date:</b> 11/8/2011	<b>Time:</b> 09:04 AM	<b>Report ID:</b>
<b>Property:</b> 186 South Drive St. Simons Island Ga 31522	<b>Customer:</b> Mr. Owners Manual	<b>Real Estate Professional:</b>

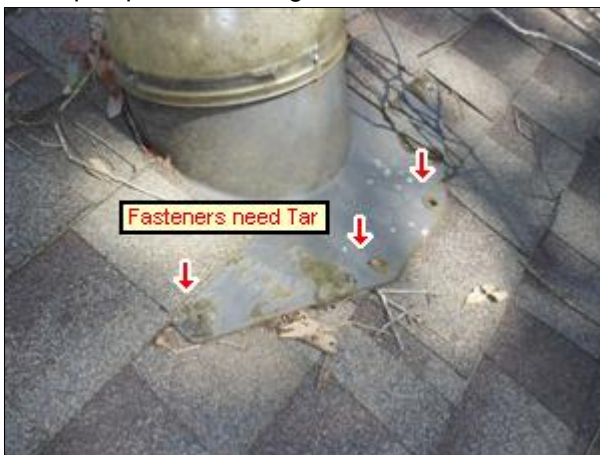
(1) roof penetrations need repairs Ski light flashing and Plumbing stacks, and roof vents need tar over nails.(Picture 1)(Picture 2)(Picture 3) Also the Recommend a qualified Roofing contractor inspect and repair as necessary. These repairs will help to prevent damage in the future.

1.2 Picture 1 Fasteners need tar

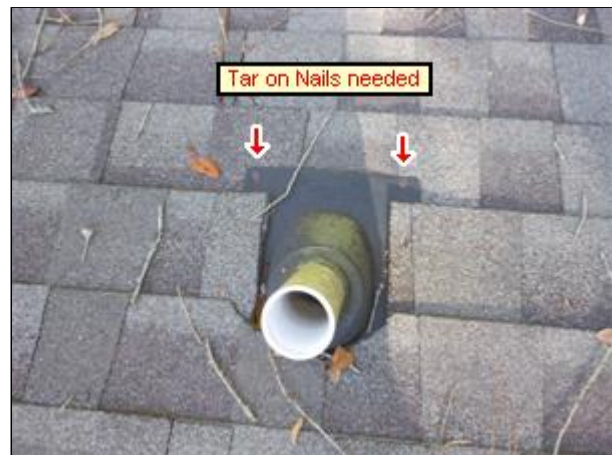
1.2 Picture 2 Fasteners need tar

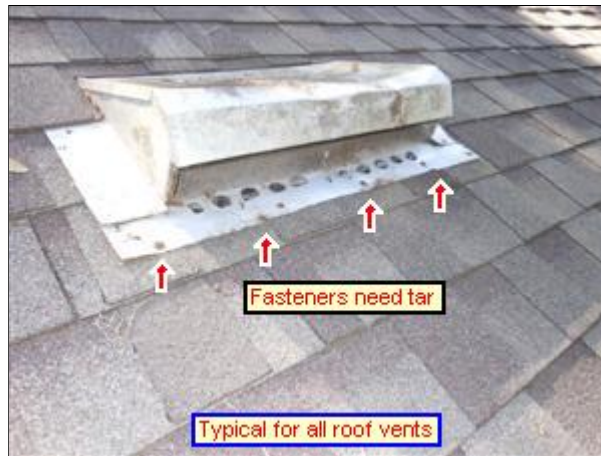
1.2 Picture 3 Fasteners need tar

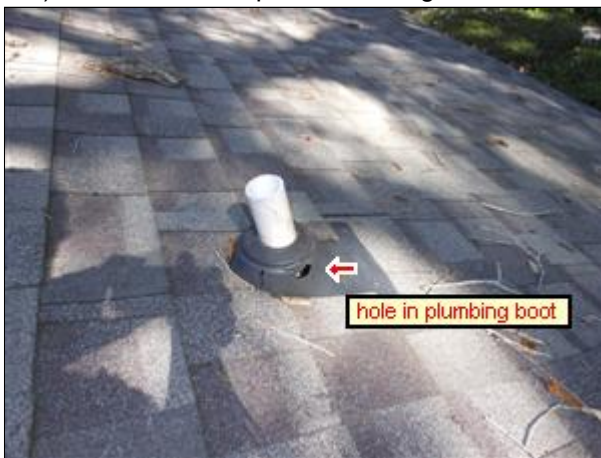
(2) Plumbing vent pipe flashing, located on the right side of the home, is broken and needs to be replaced.(Picture 4)(Picture 5). Recommend a qualified roofing contractor inspect and repair as necessary.

1.2 Picture 4 Hole in Plumbing stack boot

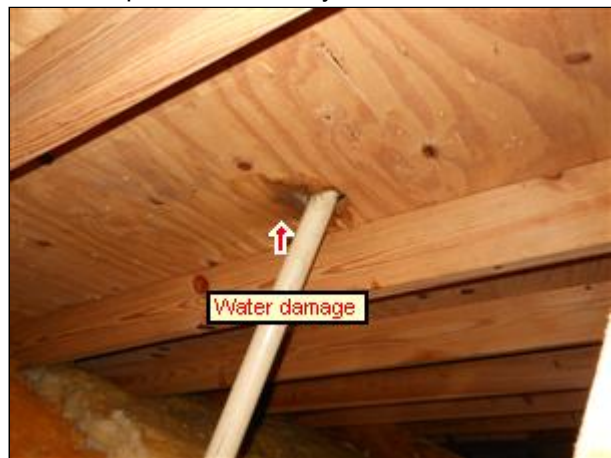
1.2 Picture 5 Water staining on plumbing stack that has the broken boot

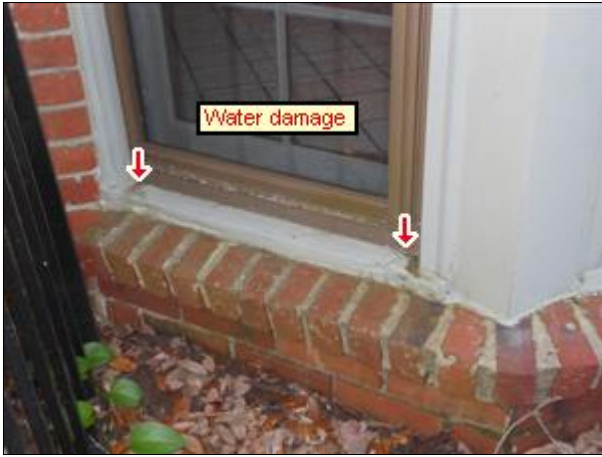
(1) The window trim at the bay window of the kitchen breakfast nook was water damage. (Picture 1)

2.0 Picture 1 Water damage at window

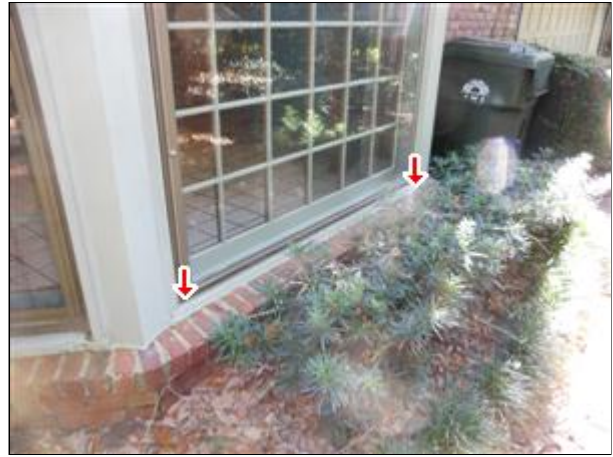
2.0 Picture 2 Water damage at window

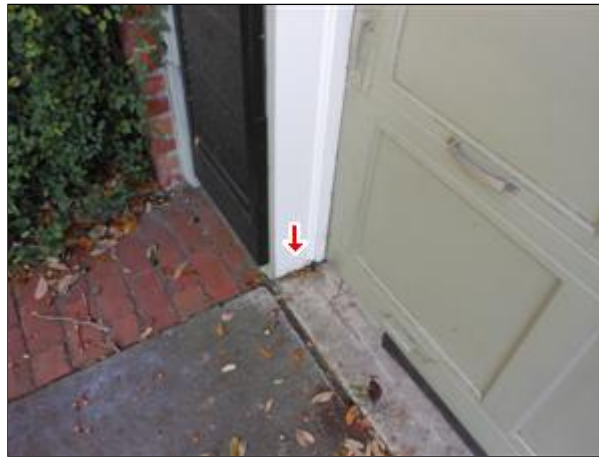
(2) Garage door side wall trim shows signs of water damage.(Picture 3) Further damage will occur if not corrected.

2.0 Picture 3 Water Damage to wood trim

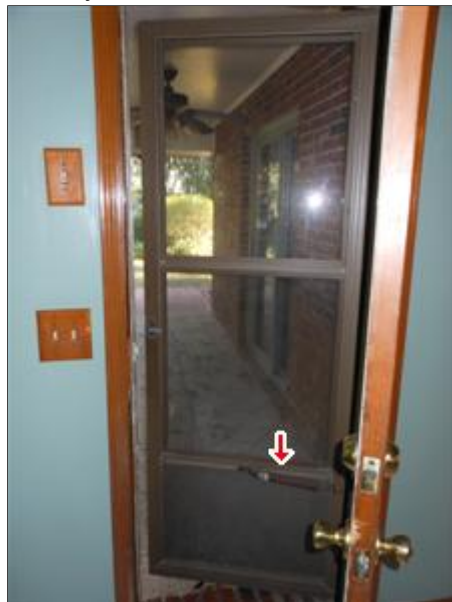
(1) Screen door at breakfast nook has a weathered closer stays open when you open it (Picture 1). Recommend a qualified person inspect and repair as necessary.

2.1 Picture 1 Broken closer

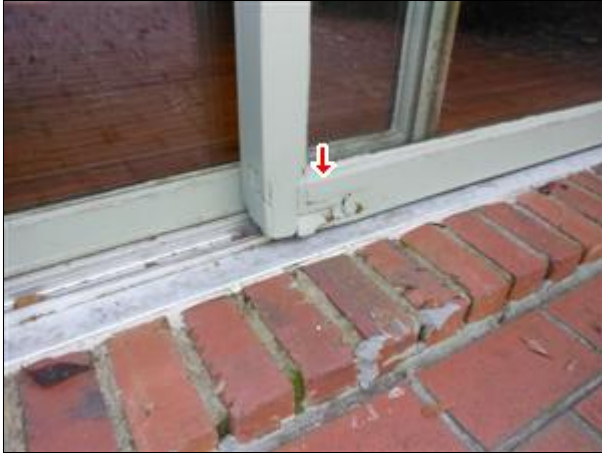
(2) Sliding glass doors at rear of home has water damage at the bottom of the doors.(Picture 2)(Picture 3)(Picture 4)  
Further deterioration may occur if not repaired. A qualified contractor should inspect and replace as needed.

2.1 Picture 2 Wood sliding door damaged

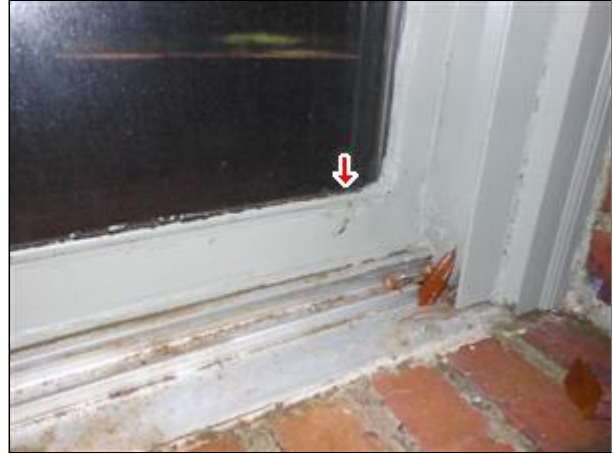
2.1 Picture 3 Water damage at sliding glass door

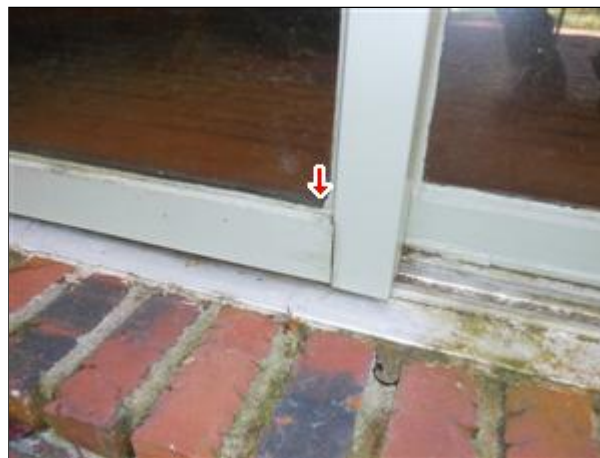
2.1 Picture 4 Water damage at sliding glass door

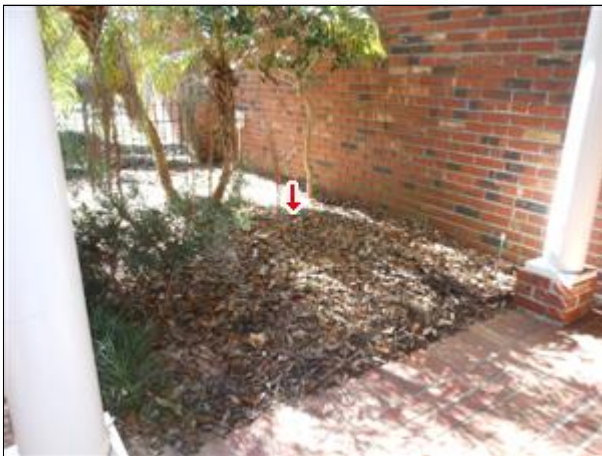
(1) Build up of leaves and mulch in the front courtyard at the entry should be lowered to help water to be directed away from the home. (Picture 1)(Picture 2)

2.4 Picture 1 Area is higher then brick porch

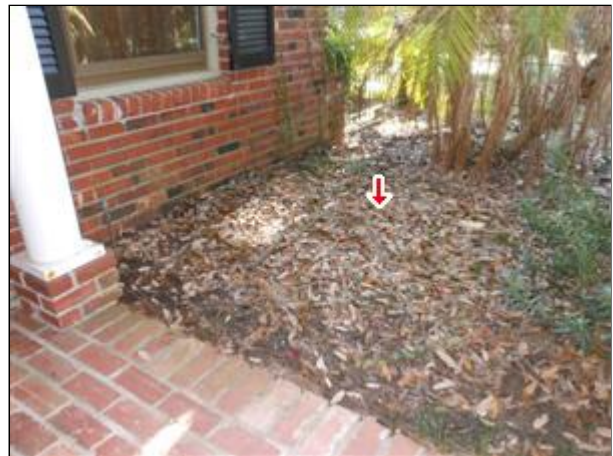
2.4 Picture 2 Area is higher then brick porch

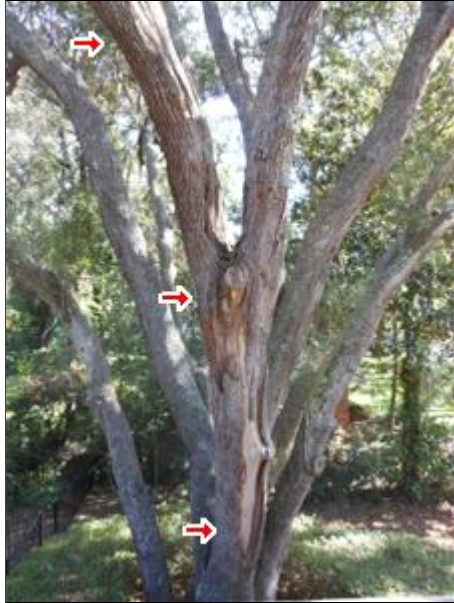
(2) Tree on the right side of the home appears to have been struck by lightning and is leaning towards the home.(Picture 3)  
Recommend a qualified Arborist inspect and treat as necessary.

2.4 Picture 3 Tree limb lost bark and appears to be deteriorating

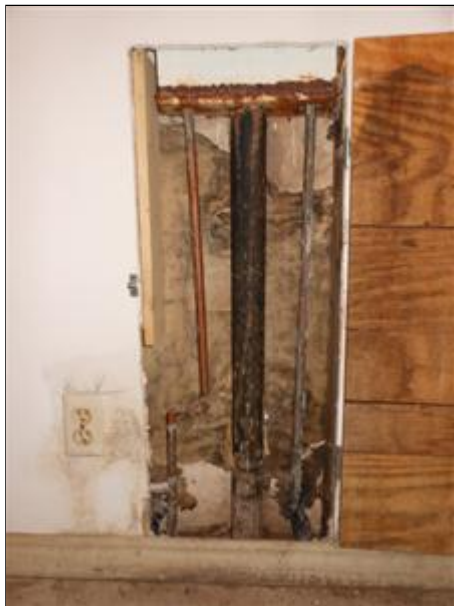
Signs of fungi growth is present on the wall in the garage closet, closest to the Garage Door. We did not inspect, test or determine if this growth is or is not a health hazard. The underlying cause is moisture (Picture 1). I recommend you contact a mold inspector or expert for investigation or correction if needed.

3.1 Picture 1 appears to be Black mold should be removed

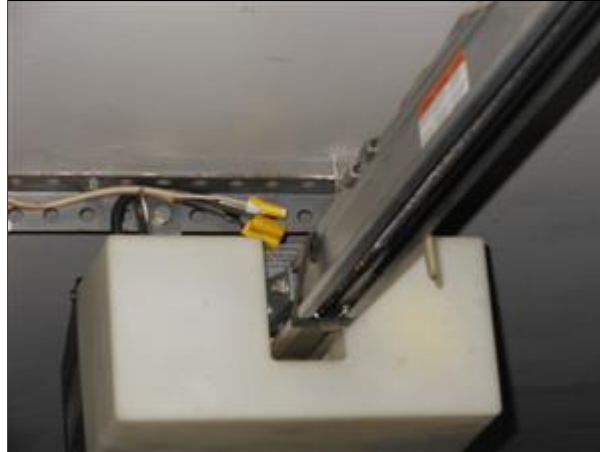
The power to the garage door opener has not been connected, wires are on the face of the opener. Electrical wires for a Garage Door opener is not a direct wire connection (Picture 1). Wires need to be placed in a box in the ceiling with receptacle and cover plate installed. Recommend a Licensed Electrical contractor inspect and repair as Necessary. All Electrical issues are considered hazardous and should be repaired.

3.5 Picture 1 Garage Door Electrical connection not complete

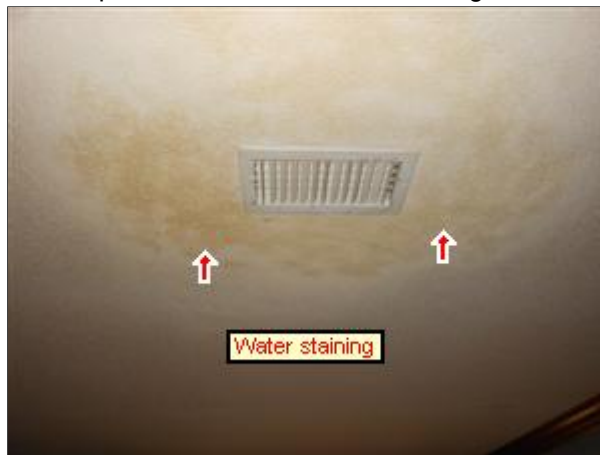
There is a water stain around the HVAC register in the Living room and appears to be from condensation around the register. (Picture 1) Inspection in the attic sheetrock in this area didn't show signs of water staining. HVAC Register boots should have insulation all around to prevent hot air of the attic mixing with the metal on the boot.

4.0 Picture 1 Water staining on ceiling

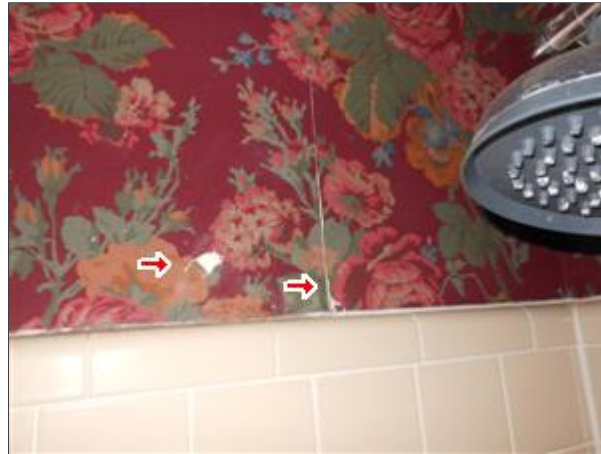
(1) The Wallpaper on the wall is peeling in areas at the master bath. (Picture 1) While this damage is cosmetic, it needs to be repaired. A qualified contractor should inspect and repair as needed.

4.1 Picture 1 Wallpaper torn and loose on wall

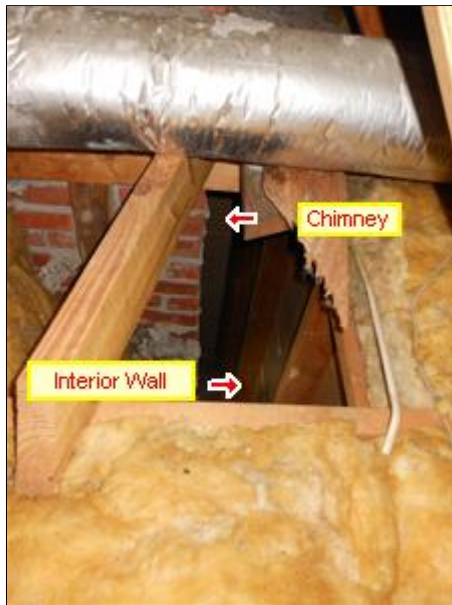
(2) The walls that surround the fireplace chimney box and stack in not insulated or sealed off from the attic temperatures.(Picture 2)(Picture 3) This is a efficiency concern and is for you information and use.

4.1 Picture 2 Area around chimney

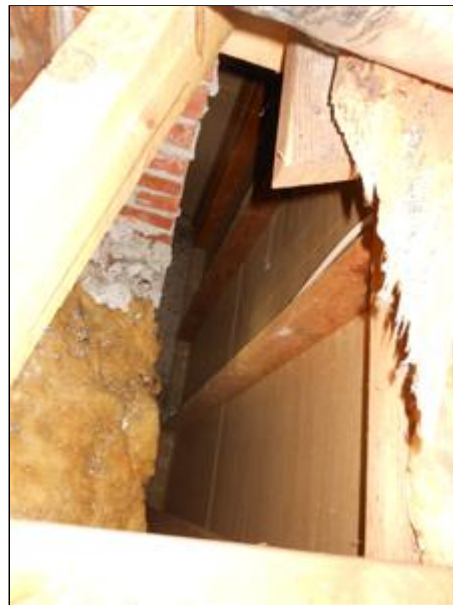
4.1 Picture 3 Area around chimney

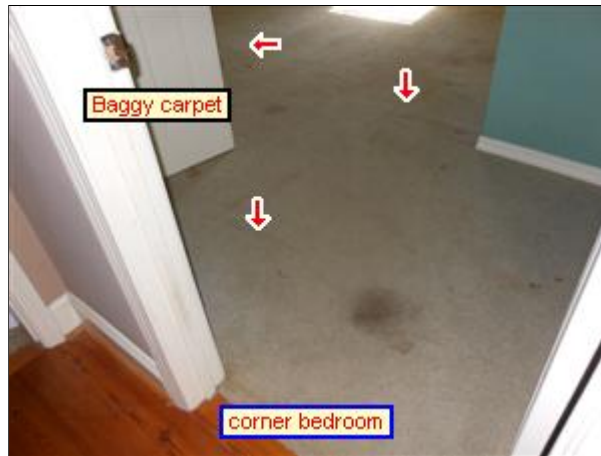
The Carpet is loose or baggy and not stretched for a tight installation at the Guest Bedroom (Picture 1). Repairs are needed. A qualified contractor should inspect and repair as needed.

4.2 Picture 1 Baggy Carpet

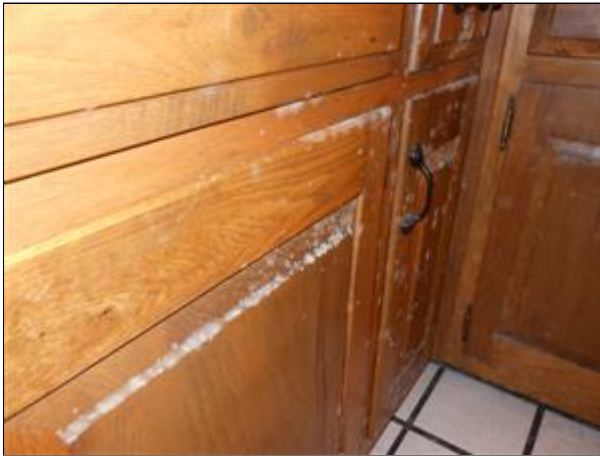
Cabinet doors and counter tops have visible signs of mold . Eradication of this mold will prevent damage to the wood grain of the cabinets. The mold doesn't appear to be dangerous, its always recommended to have mold tested to verify health concerns. Recommend repair or replace as necessary.

4.3 Picture 1 Mold on cabinets

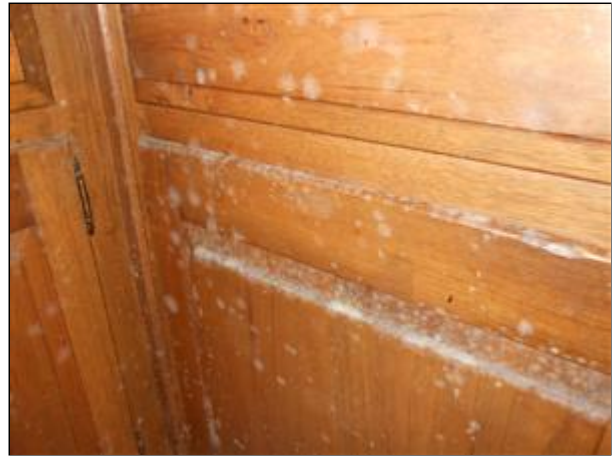
4.3 Picture 2 Mold on cabinets

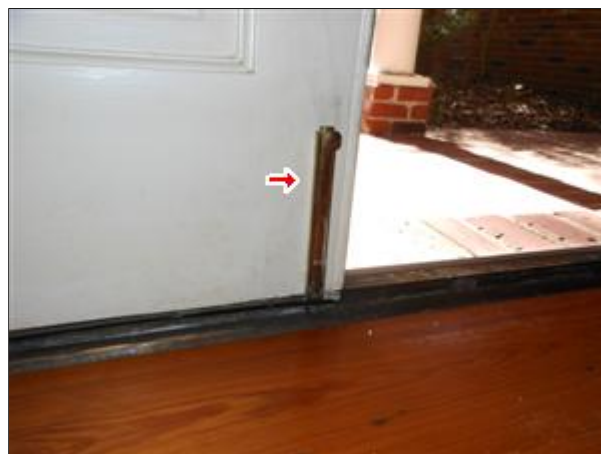
(1) Front door fixed door bolt at the bottom was not operational allowing the bottom of the fixed door to move.(Picture 1)  
Further damage will occur if not corrected.

4.4 Picture 1 Door Bolt needs repairs

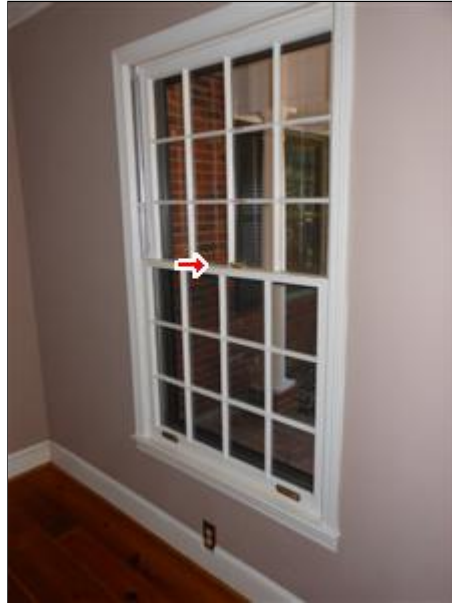
Window right as you come in the entry has a broken window latch. (Picture 1)

4.5 Picture 1 Latch broken

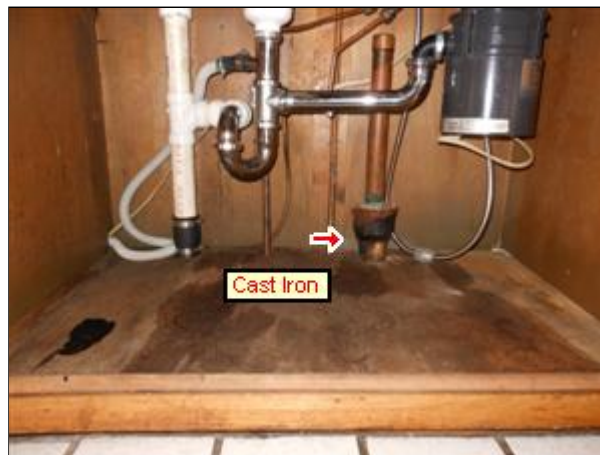
It appears that the Plumbing drain system in the home is Cast Iron. Recommend a Qualified plumber inspect the condition of the pipe by scoping the line. (Picture 1) Repairs and or replacement of pipe could be very expensive since the pipe is located under the slab.

6.0 Picture 1 Cast iron drain pipe

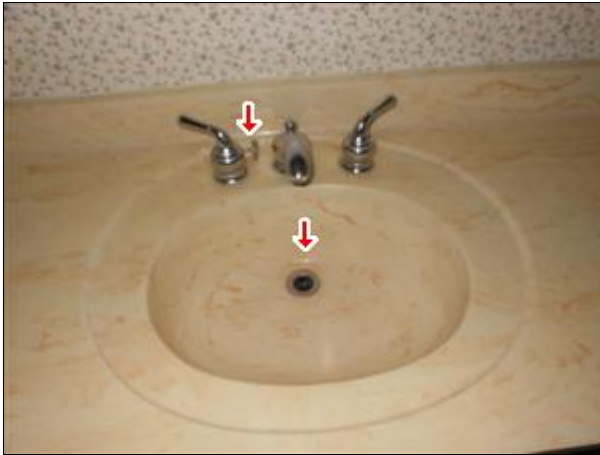
(1) The Stopper doesn't work in the Hall Bathroom (Picture 1) and in the Master Bathroom the sink has a slow drain (Picture 2)(Picture 3). This is a function of the sink and should be repaired.

6.1 Picture 1 Stopper removed and doesn't work

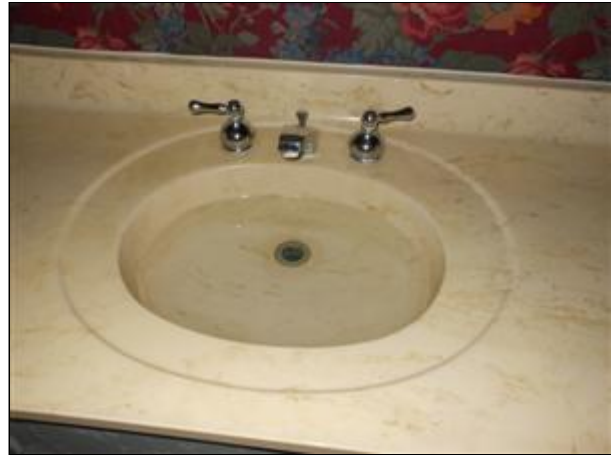
6.1 Picture 2 Master bathroom sink holds water

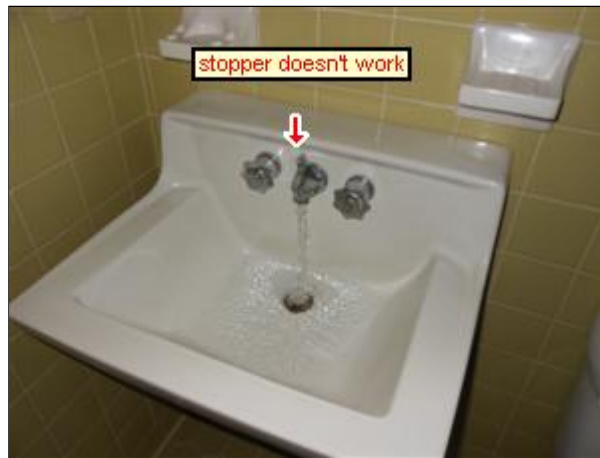
6.1 Picture 3 Stopper doesn't work

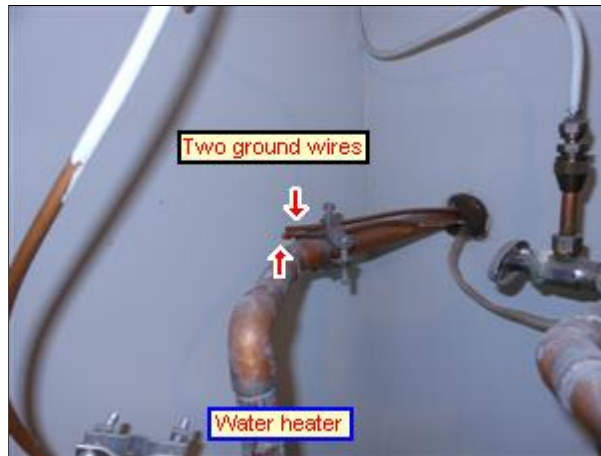
(2) There is a bond wire to the metal plumbing but it is not within 5 feet from where plumbing line enters home. (Picture 1) If you choose to correct, there should only be one bond wire to the metal plumbing so the one in wrong location should be removed. I recommend an electrical contractor install a ground wire and clamp on metal plumbing line within five feet from where plumbing line enters home and remove the old location.

7.0 Picture 1 Recommend a qualified Electrical contractor inspect and repair

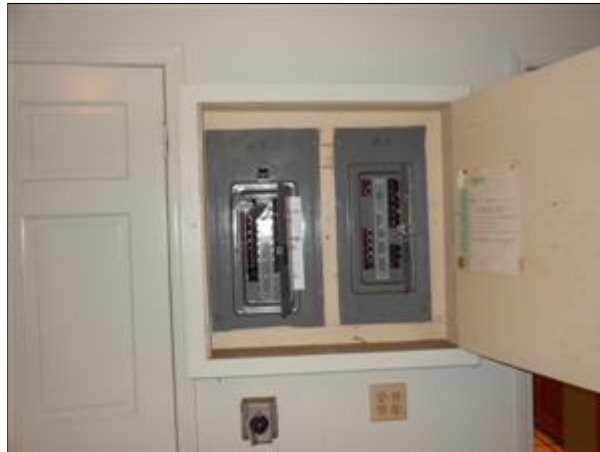
You have a Federal Pacific panel which is legal, but there is a possibility that the circuit breakers may not trip when shorted possibly causing an electrical hazard.(Picture 1) Opinions by licensed electrical contractors on this panel varies between safe and unsafe. I recommend you consult a licensed electrical contractor for an opinion and correct if necessary.

7.1 Picture 1 Federal pacific Panels

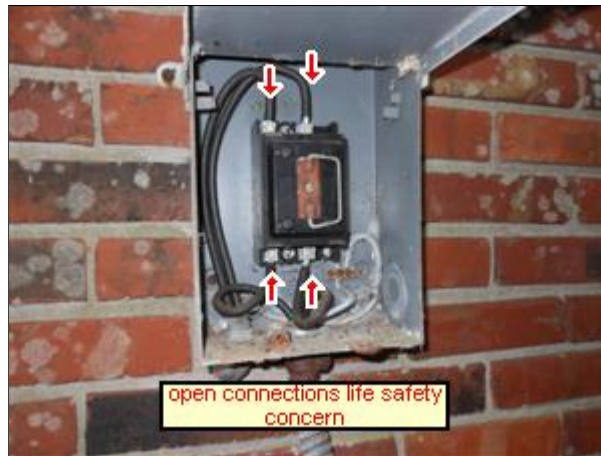
(1) The Electrical disconnect for the HVAC Condenser, located on the right side of the home, is not safe and should be replaced.(Picture 1) Electrical issues are considered a hazard until repaired. A qualified licensed electrical contractor should perform repairs that involve wiring.

7.2 Picture 1 Electrical disconnect is easily accessible and is a life safety concern.

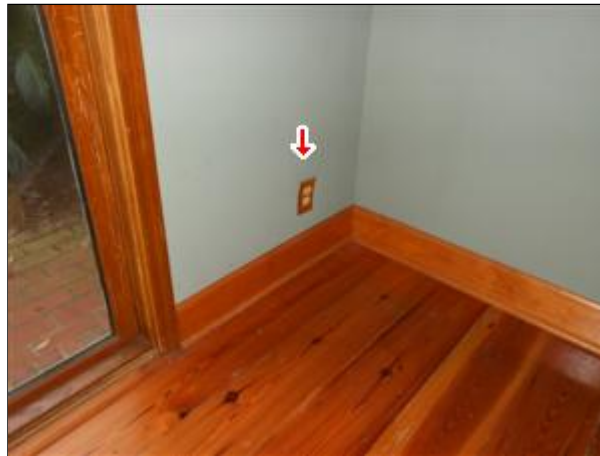
(2) Receptacle right of back of home sliding glass door is damaged and needs repaired. (Picture 2) Electrical issues are considered a hazard until repaired. A qualified licensed electrical contractor should perform repairs that involve wiring

7.2 Picture 2 Receptacle needs repairs

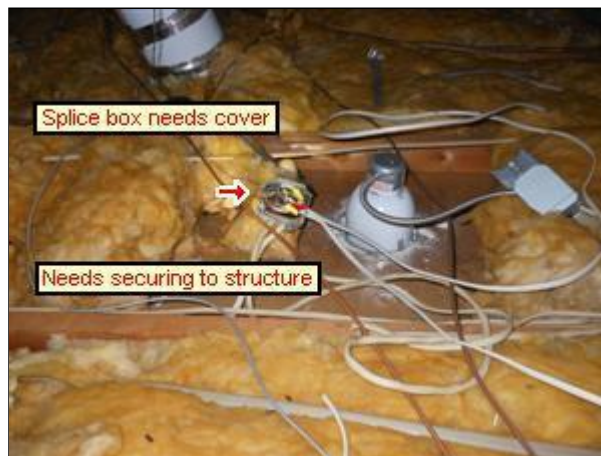
(3) Splice box needs a cover-plate within "Five feet" of attic access in attic. Electrical issues are considered a hazard until repaired. I recommend a qualified licensed electrical contractor correct.

7.2 Picture 3 Splice box needs cover and secured to structure

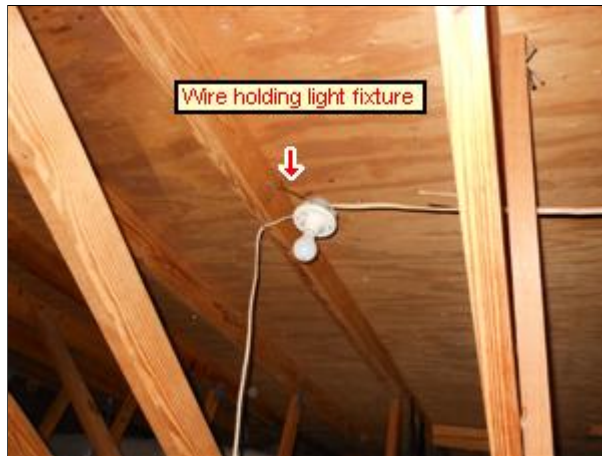
(4) One Light fixture needs securing to the structure and is located within "Five feet" of attic access in attic (Picture 4). Electrical issues are considered a hazard until repaired. I recommend a qualified licensed electrical contractor correct.

7.2 Picture 4 Light fixture needs securing to structure

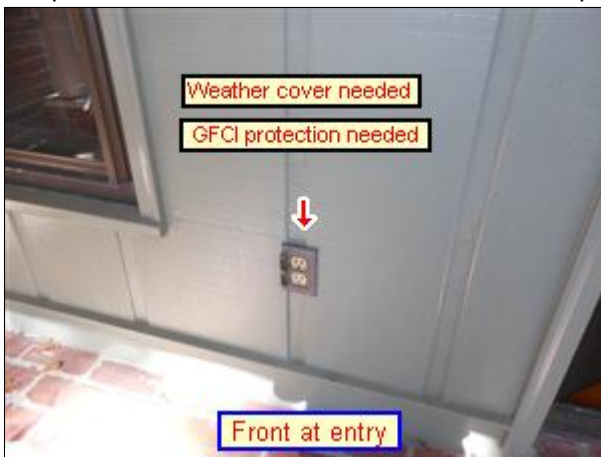
The exterior outlet at the front of home and rear of home are not on a GFCI protected.(Picture 1)(Picture 2)(Picture 3) Recommend all exterior receptacle are GFCI protected for life safety. Electrical issues are considered a hazard until repaired. A qualified licensed electrical contractor should perform repairs that involve wiring.

7.3 Picture 1 Receptacle needs GFCI protection and cover

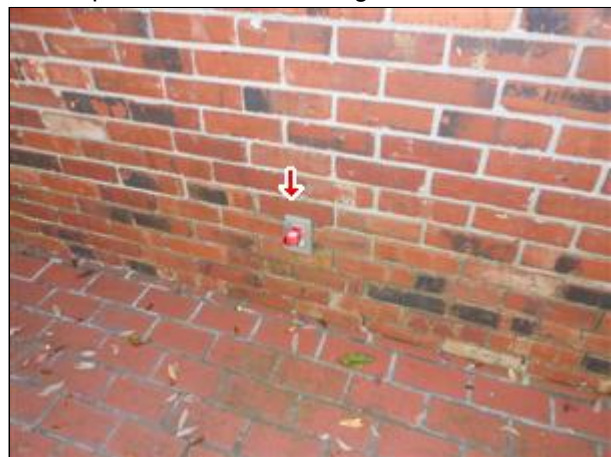
7.3 Picture 2 Receptacle needs GFCI and cover

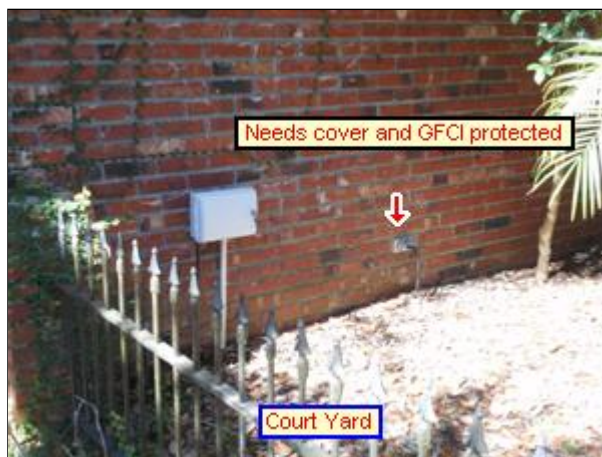
7.3 Picture 3 Receptacle needs GFCI and cover

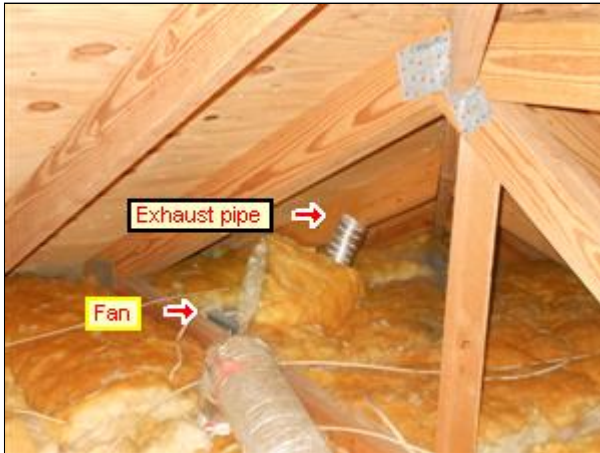
(1) The Exhaust fan does not vent to outside at the master bath (Picture 1)(Picture 2). Vent pipes that terminate in attic space can sometimes cause moisture that can lead to mold or cause condensation. A qualified contractor should inspect and repair as needed.

9.2 Picture 1 master bathroom exhaust fan pipe should terminate in the soffit Area

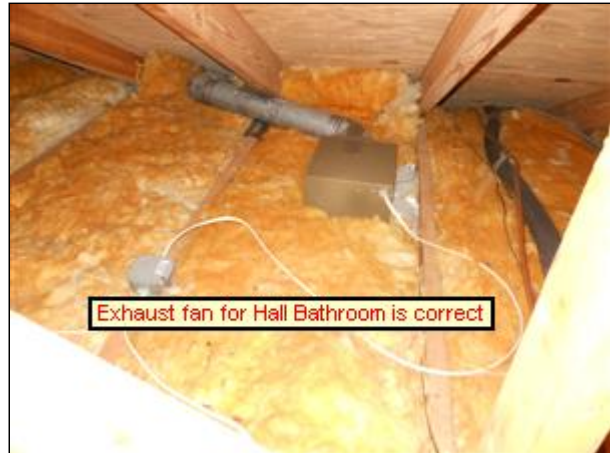
9.2 Picture 2 Exhaust fan terminates at the soffit

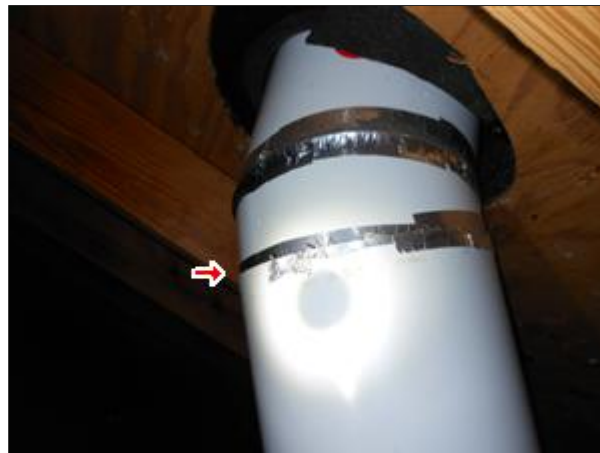
The Sono Tube lighting ductwork needs properly secured at the joints. This is will help to prevent insects from entering the home or attic area.(Picture 1) Recommend a qualified contractor inspect and repair as necessary.

9.4 Picture 1 Joint in pipe needs repaired

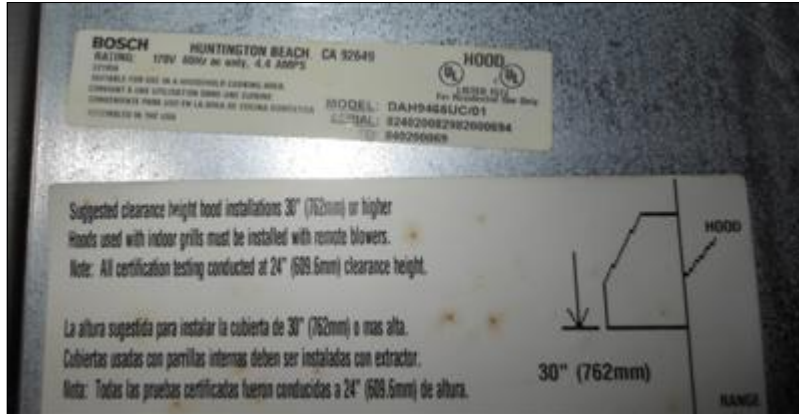
The Exhaust hood mounting height is 18" above the stove.(Picture 1) The manufacturer recommends a suggested mounting height 30" above the stove or range.

10.2 Picture 1 Range Hood height
